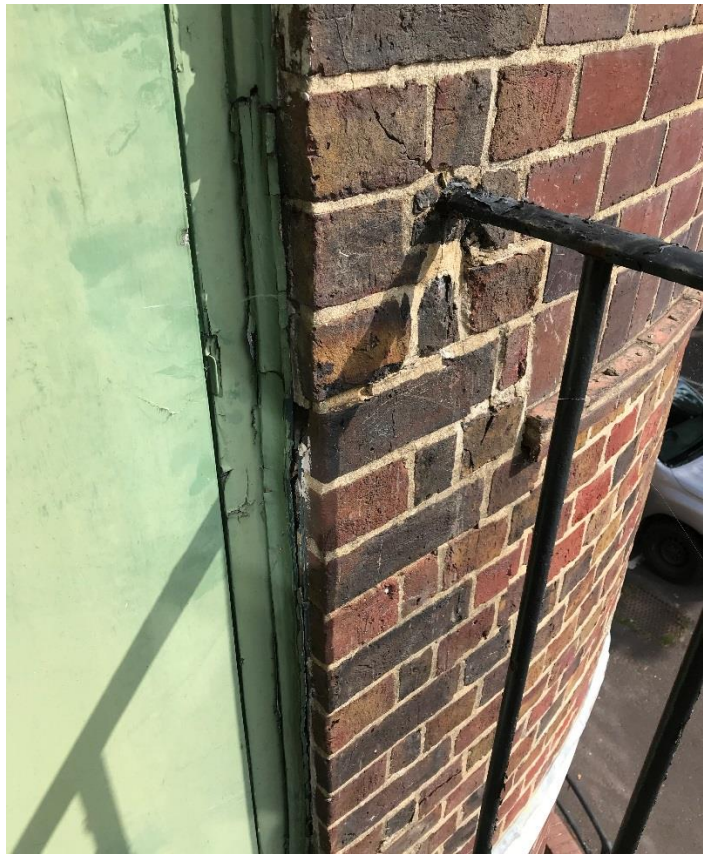
Photo 21 – Corroding/expanding metalwork, local cracking of brickwork.

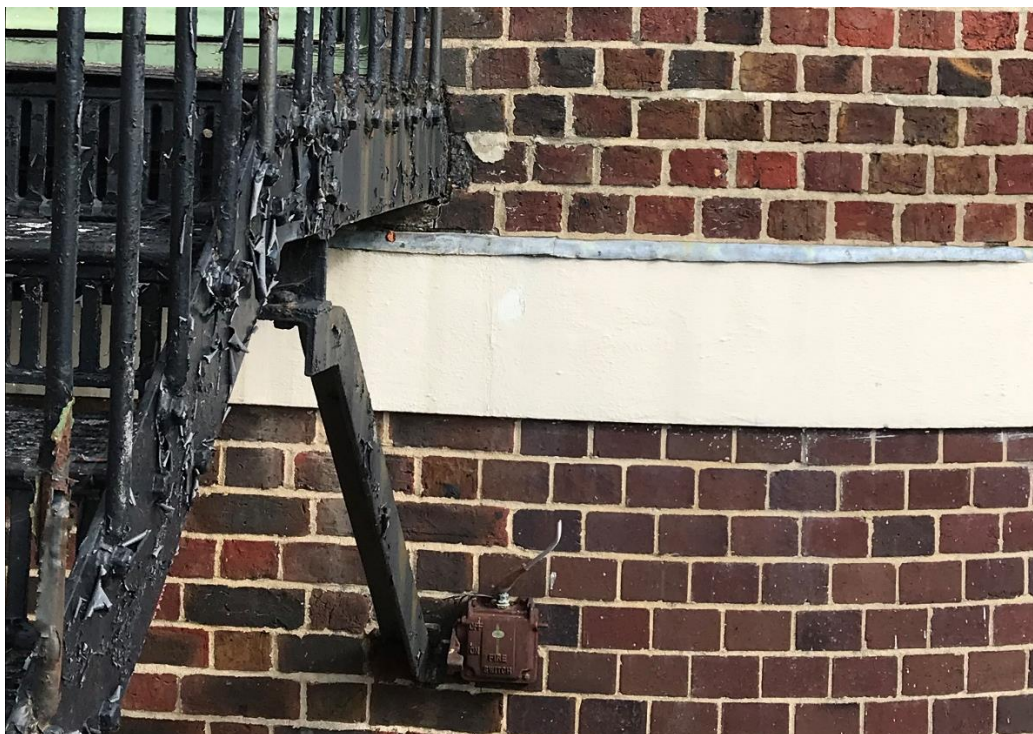
Photo 22 – Corroding/expanding metalwork, local cracking of brickwork.

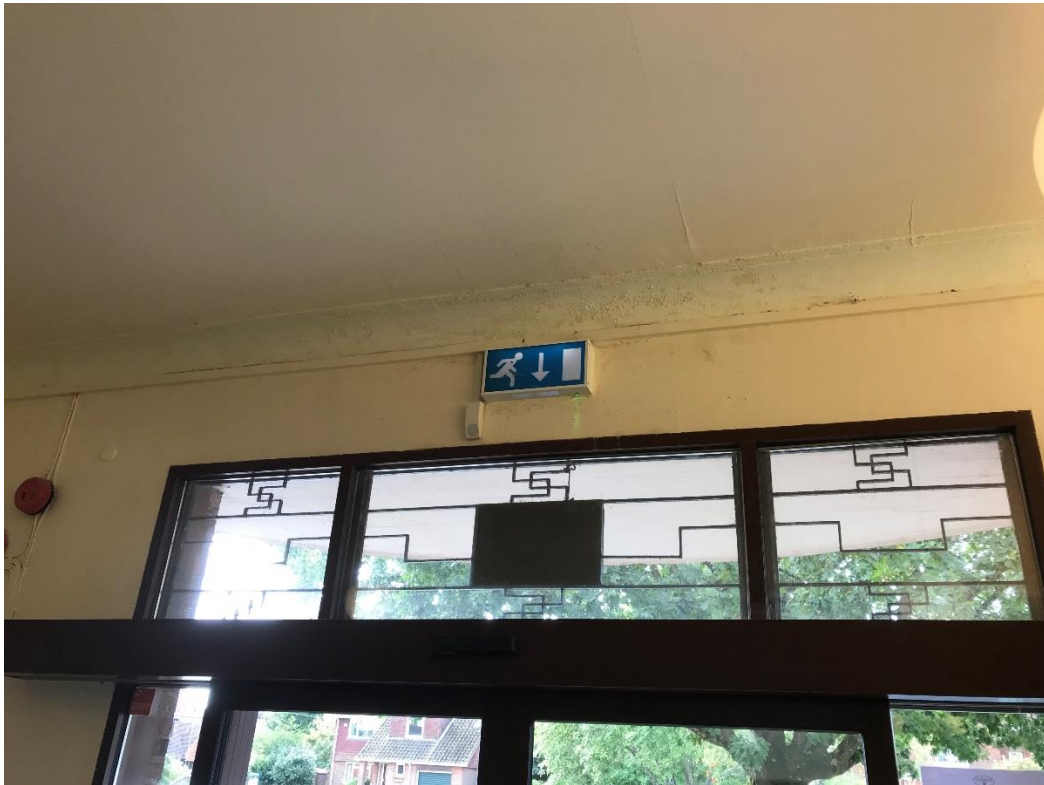
Photo 25 – Council offices, internal dampness over entrance.

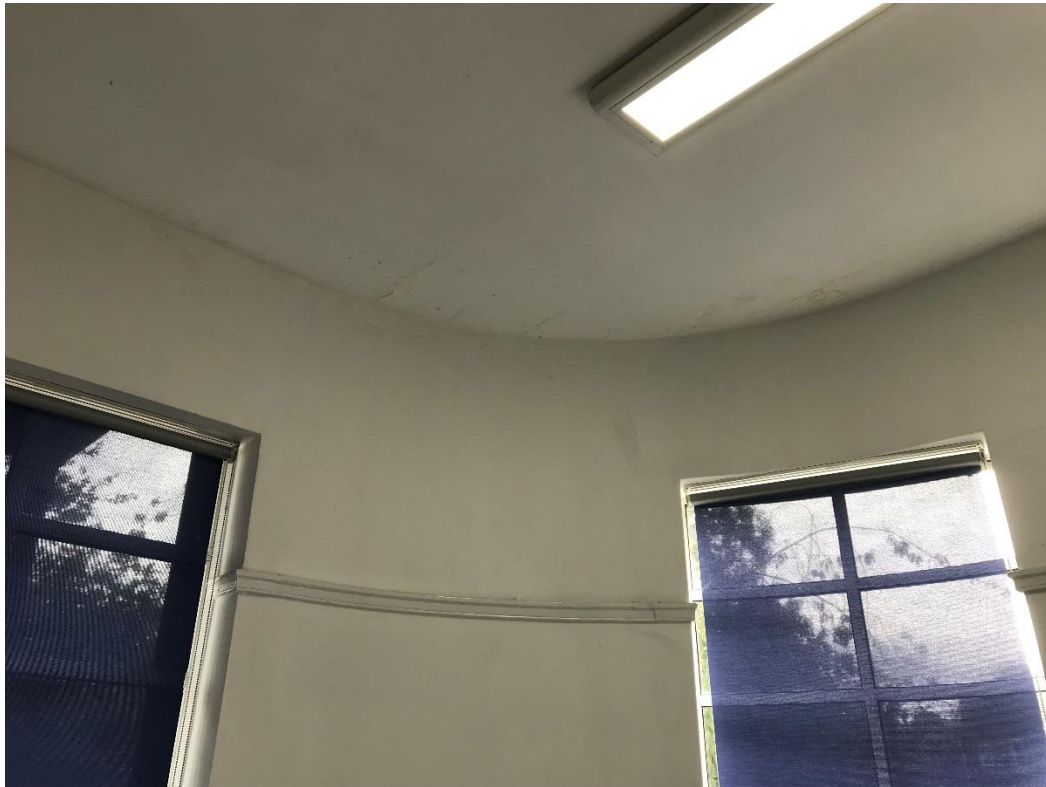
Photo 27 – Ground floor council office, dampness to coving level of inner curved wall.

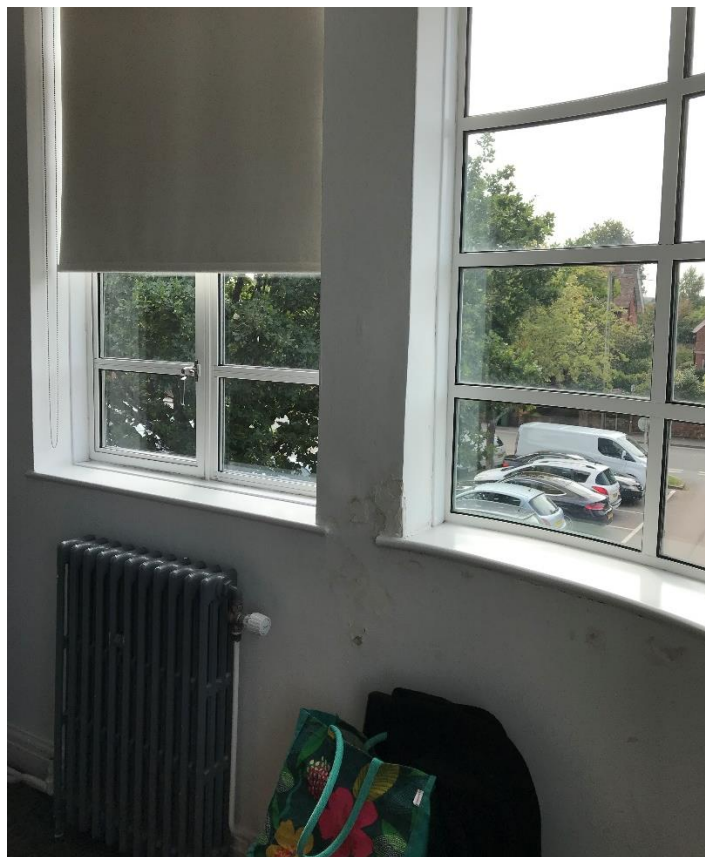
Photo 28 – First floor council office, dampness to inner curved wall.

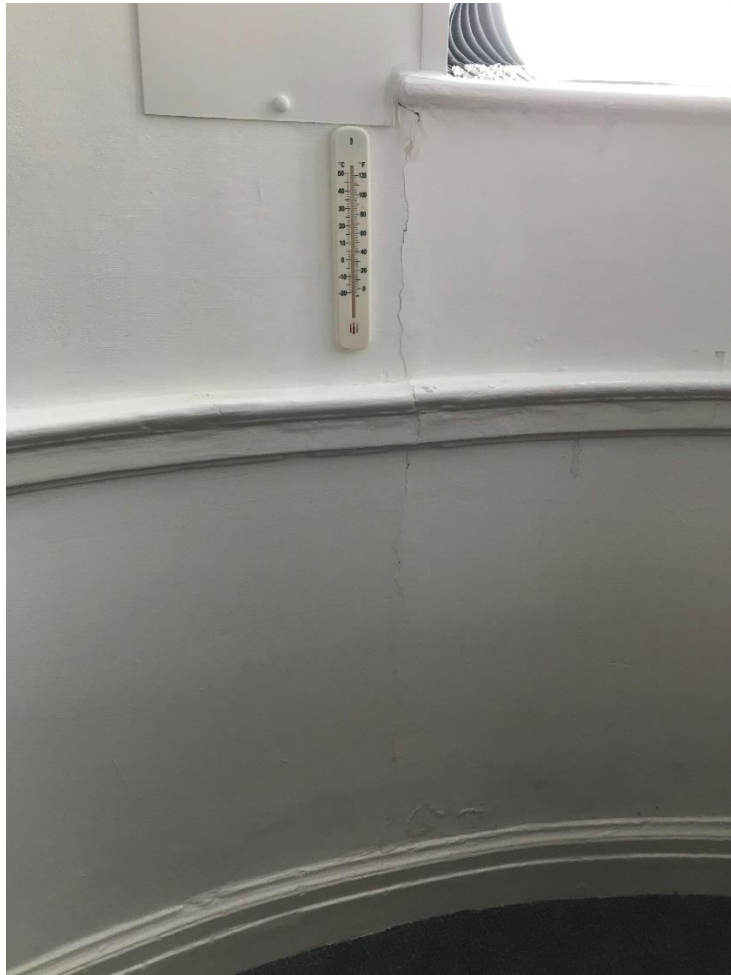
Photo 29 – First floor council office, vertical cracking to inner curved wall.

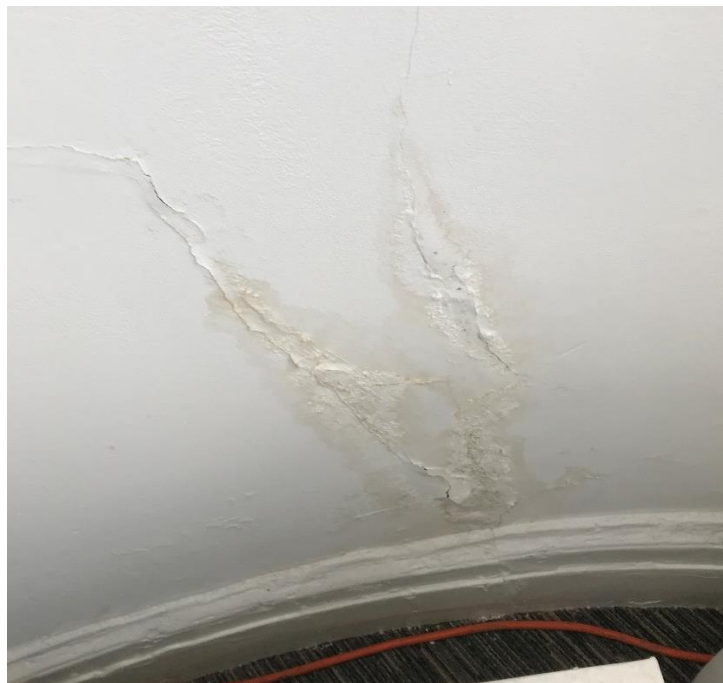
Photo 30 – First floor council office, cracking and dampness to inner curved wall.

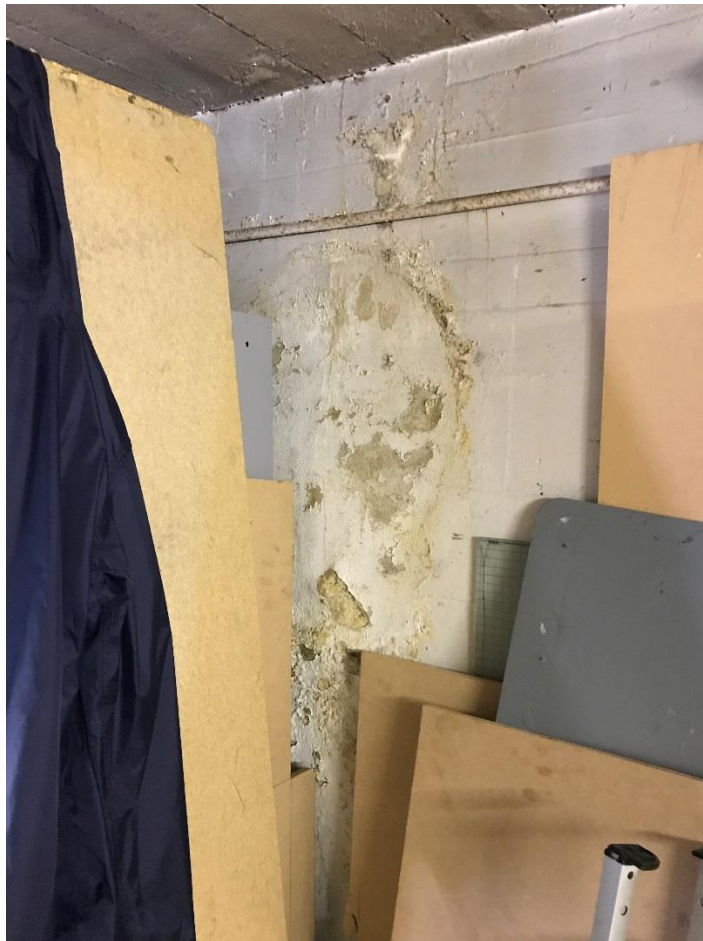
Photo 33 – Dampness to internal basement wall.

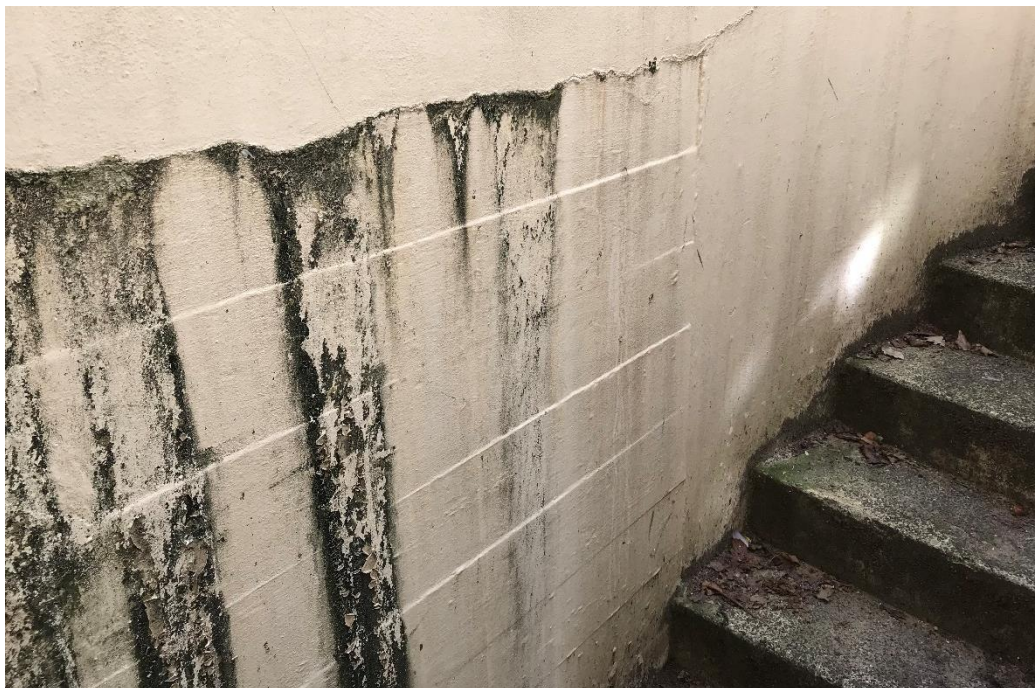
Photo 34 – Dampness to external basement access staircase wall.

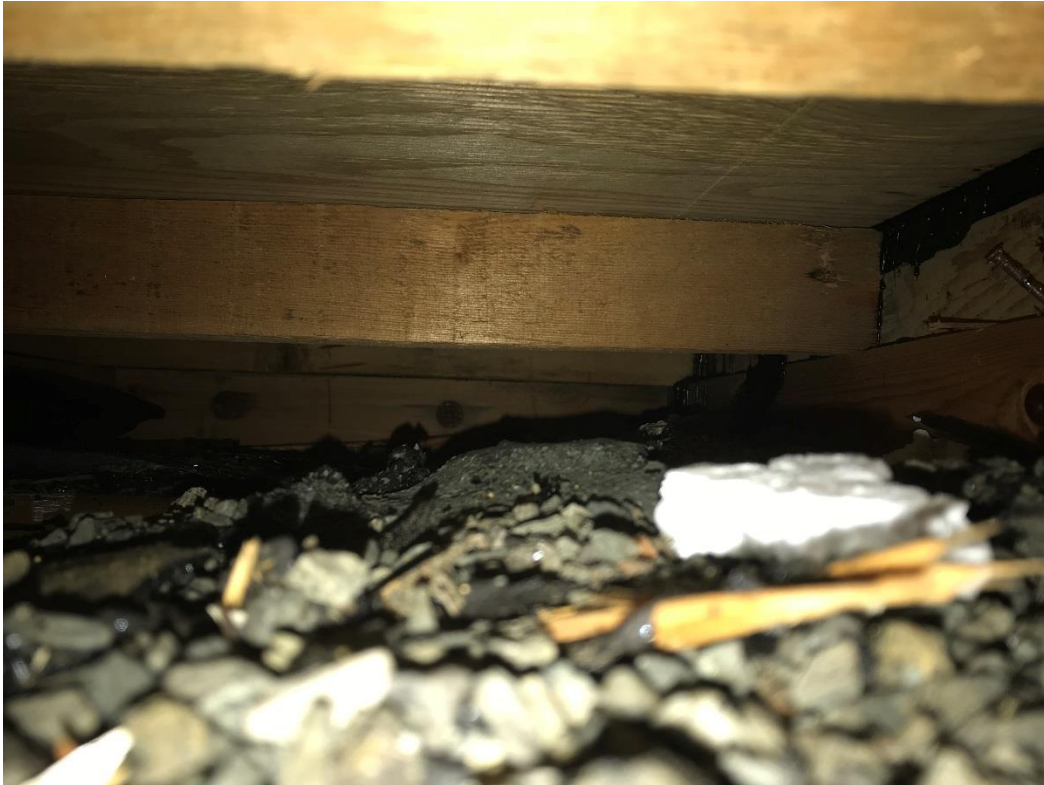
Photo 47 – Kitchen corridor, flat roof ceiling void, debris from previous roof repair, recovering.
