Petersfield Town Council Siltation and Erosion Survey

Aquatic and Environmental Consultants
Ash Girdler: B.S.c (Hons.) CBiol. MIBiol. CEnv. MIFM. FIFM

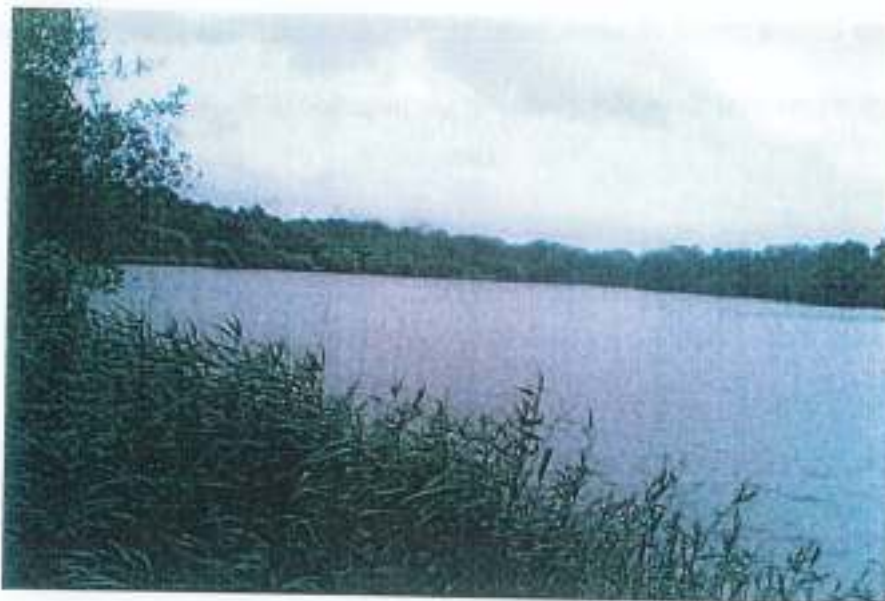
The lake is an extensive but shallow groundwater and precipitation fed lake dug out in the 18th century (*Plate 1*). It was deepened by suction dredging in the 1980's and there is a single outlet drain controlled by a sluice, and the first section stretch of the drain is culverted.

Plate 1 - Petersfield Heath Lake, shallow groundwater and precipitation fed

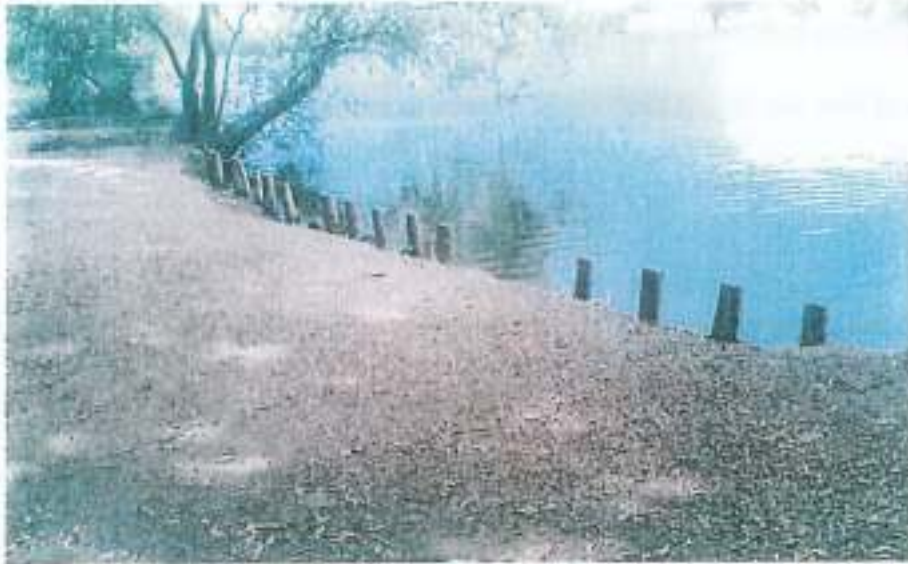
The survey details existing bank and erosional features around certain sections of the lake, it is worth noting here that there are a number of erosion mitigation techniques already in place at certain points around the lake which have worked to a lesser or greater degree. These include spiling (*Plate 2*) and railway sleepers used to provide a hard revetment to reduce further bank erosion; unfortunately the geomorphology of the area is made up of loose un-consolidated sandy material and these measures are proving ineffectual.

Plate 2 – Existing erosion control measures employed at certain points around Petersfield Heath Lake.

The continued erosion of banks at the site is another serious issue which needs to be taken into account and it seems that to improve and extend the mitigation measures already in place might not be to go far enough. The spiling (hard revetment) appears to be not working terribly effectively in the localised areas where it is situated and increasing the number would not offer a long term solution.

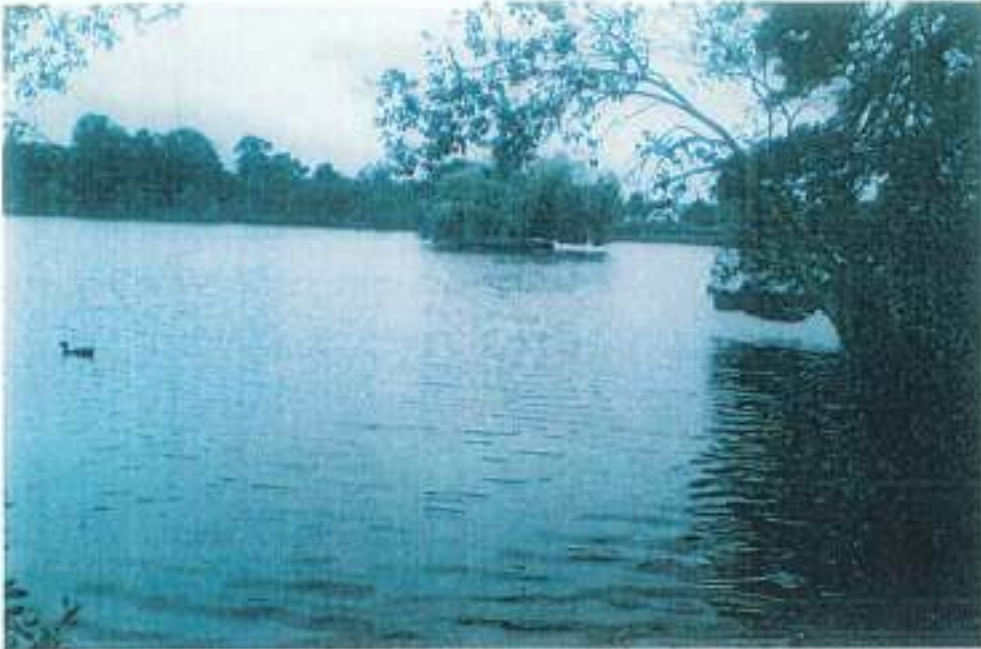
Not all sections of the lake were heavily silted and parts of the lake such as the area around the island and to the south side of the lake were virtually silt free (*Plate 3*). The maximum silt levels recorded were 65cm in places with the average result 20.11cm if accounting for the lake as a whole.

Plate 3 – Island section of the lake where silt levels were decreased

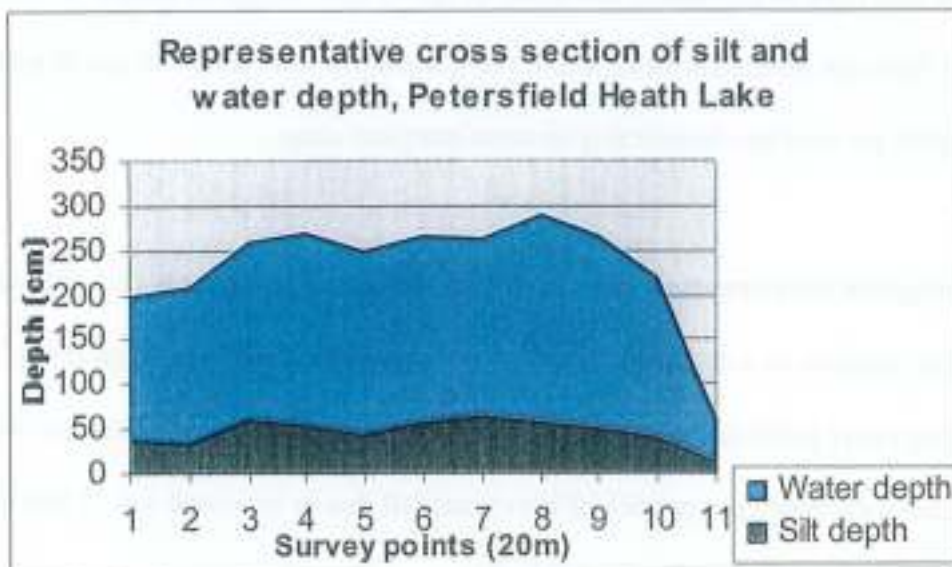
The detailed measurements of the siltation survey is presented as *Appendix 1-4*, the data shows that the figures are representing is that the lake is both deepest and contains most silt towards the centre of the lake. There is a pronounced sand bar to the eastern corner of the lake and silt deposits tended to be more concentrated in the centre of the lake with little or no silt in the margins.

Figure 4 and *5* show graphically the amount of silt in the lake at various survey points working both across and along the pond. These diagrams show the elevated levels of silt found particularly in the centre of the pond and give some idea of the issues the lake may have.

Figure 4 – Representative cross section of silt and water depth, Petersfield Heath Lake

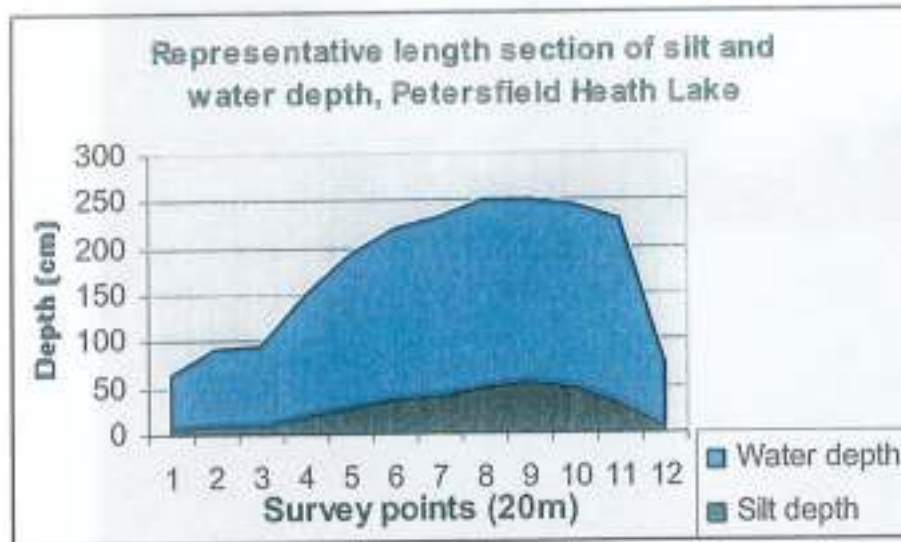
Figure 5 – Representative length section of silt and water depth, Petersfield Heath Lake

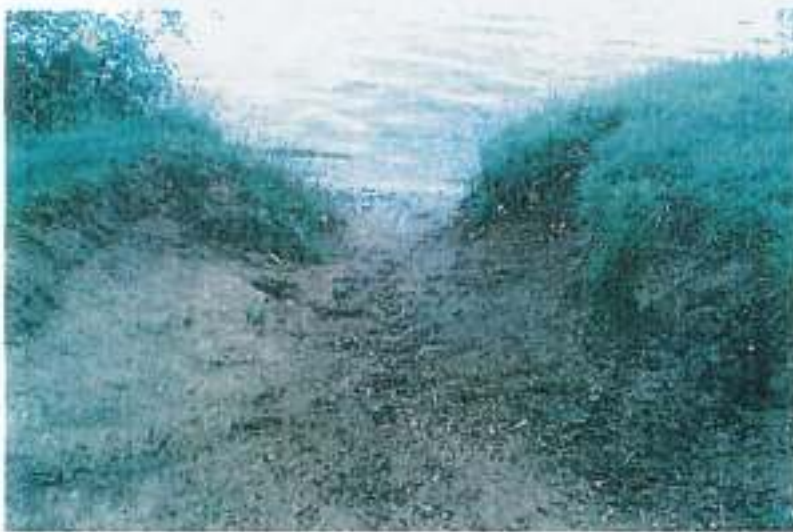
The erosion of the margins of the lake is contributing directly to the siltation load; this can be seen at a number of areas around the lake (*plates 4-6*). The erosion problems around the lake have as previously discussed (*Page 6*) been mitigated against to some extent but there are numerous areas where these measures have not been put in place and the banks are eroding considerably in some marginal areas.

Plate 4 – Lack of defences has led to erosional features in the margins

By placing coir revetments 5m out from the existing bank and then backfilling with the sediment from the lake (removing silt) it would not only address the erosion and siltation problem but also build out the banks from under the trees to allow more light into the vegetated margins (*Figure 7*). This will also go some way to stopping transport towards the lake of fine material from the footpath.

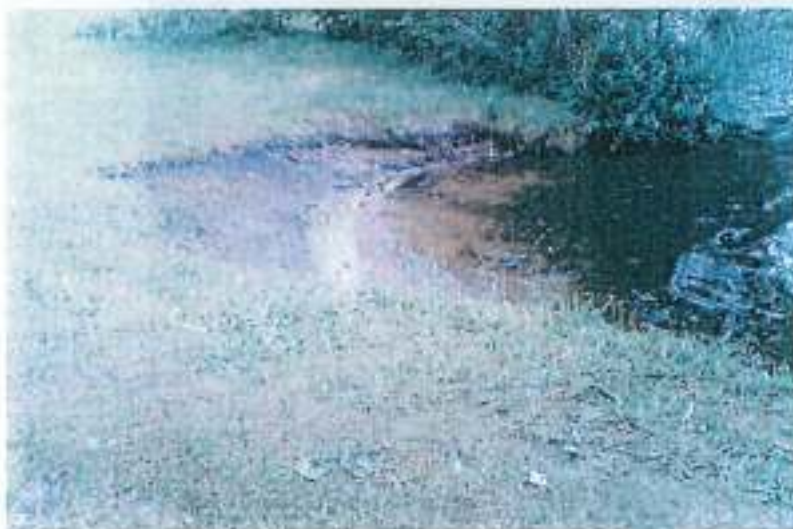
Plate 5 – Erosion feature to the North of the lake where bank erosion was considered to be worse

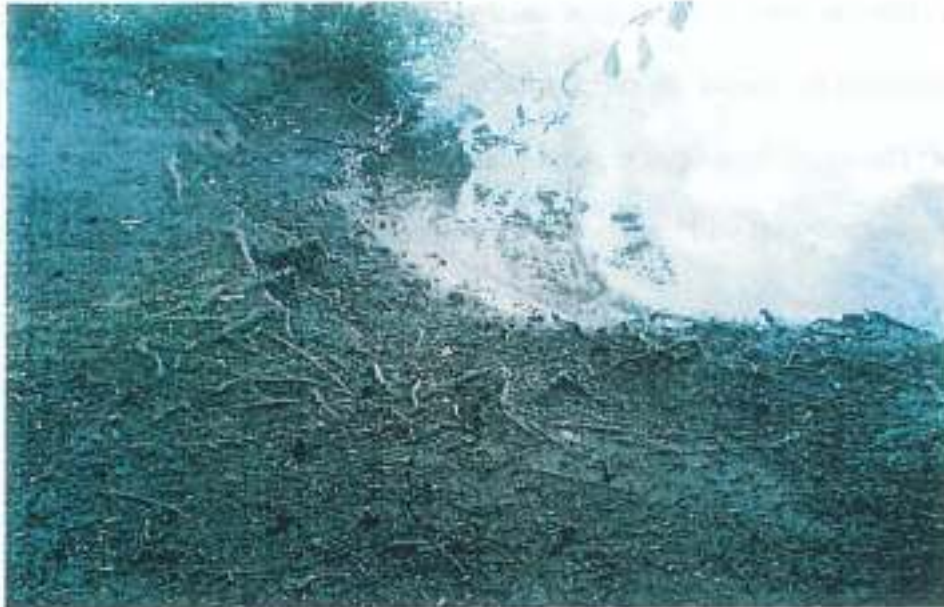
Plate 6 – Eroded landscape feature to the West of the lake exacerbated by high runoff

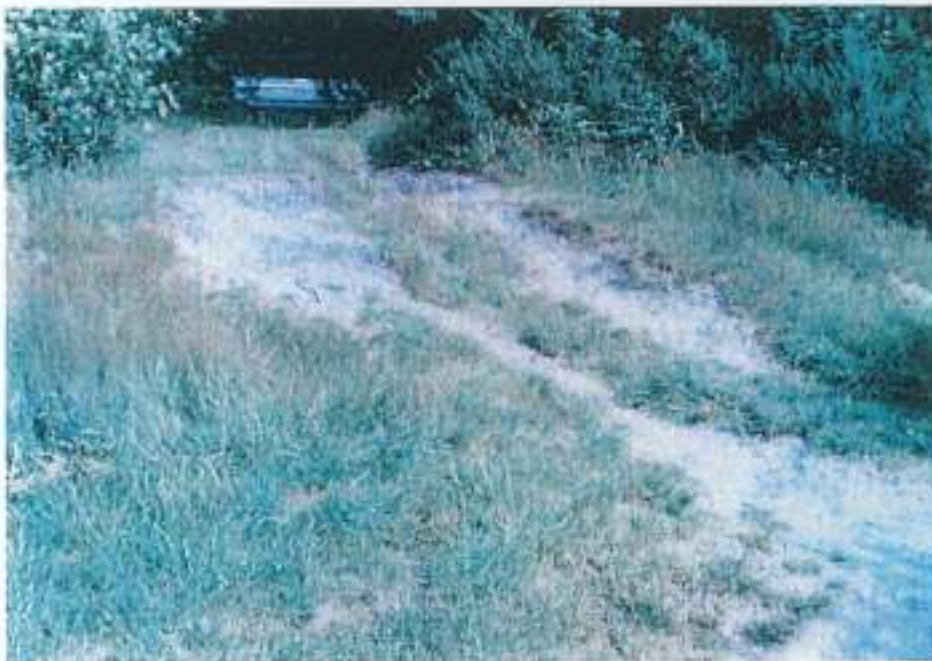
Evidence of this has been found at locations around the site (*Plate 7*) and mitigation must be considered to resolve the problem of high sediment yield runoff entering the lake system. The image highlights the issue caused by the surrounding landscape and any management proposal will have to consider this problem when looking at the lake system.

Plate 7 – Evidence of intense runoff erosion feature feeding directly into the lake

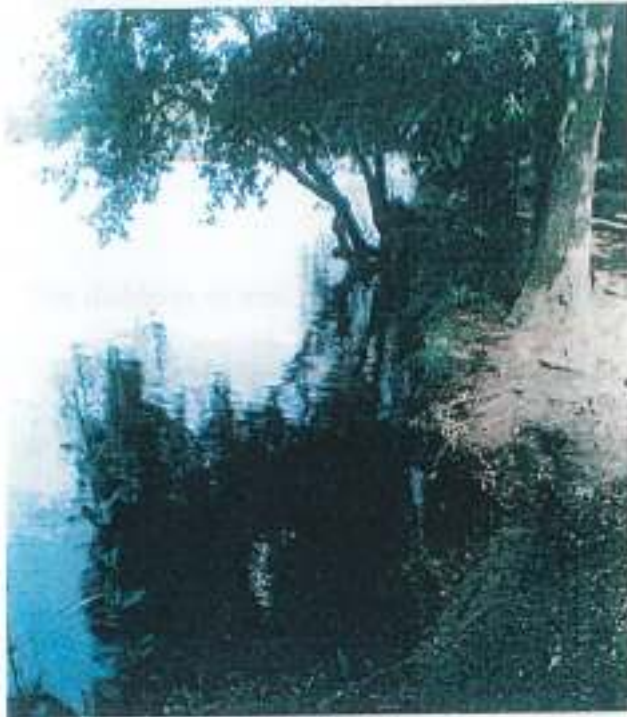
A further issue which is directly affecting the silt input in the lake and also affecting the overall health of the lake system is marginal shading from large trees situated around the lake margins (*Plate 8*). This shading is having a detrimental effect on the health of the lake in a number of ways: firstly, as the trees are mainly deciduous there is a lot of leaf fall in autumn months which is decomposing in the lake thus increasing the silt input.

The marginal shading from the tree canopy is very pronounced over large sections of the lake, illustrated in *Plate 8*.

Plate 8 – Marginal tree canopy shading affecting the productivity of the site

It is understood that a tree survey has been carried out on the site; it is recommended this survey is used to assess the appropriate management of problem trees. The plan at least should include all trees impeding excess leaf into the lake system thus exacerbating the siltation problem. This is seen as a medium to long term solution to the silt problem because even if the lake is dredged, without the pollarding or removal of tree canopies over the lake the silt problem will persist.

A further and serious concern is the detrimental impact that the trees positioned on or close to the margins of the lake are having on the aquatic ecology and biodiversity value of the Lake. Tree canopy shading has two effects, the lack of light does not encourage plants to establish and grow, and it also does not warm the water up. It is only in the presence of sunlight and warmth that phytoplankton (microscopic plants such as algae) can flourish and grow. This is a serious issue the A.G.A Group would advise addressing to increase the ecological potential.

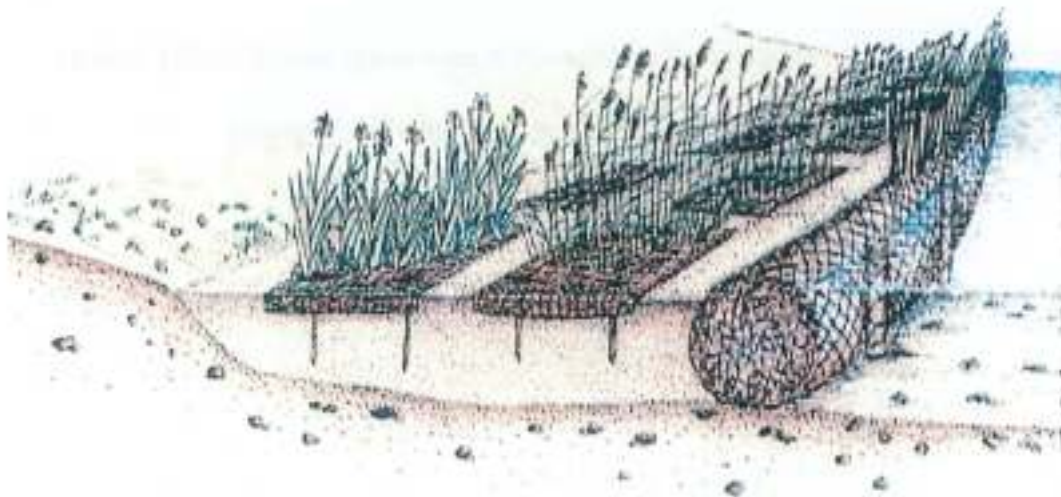
Figure 7 – Proposed solution to both bank erosion and silt intrusion

This would serve to improve the amenity and reduce the risk of future erosion problems by keeping the bank away from footpath and making room for anglers, whilst reducing the impact from walkers. The A.G.A Group has put this proposal forward as a solution to both control erosion and silt inputs into the lake and increase the biodiversity and natural habitat of the site.

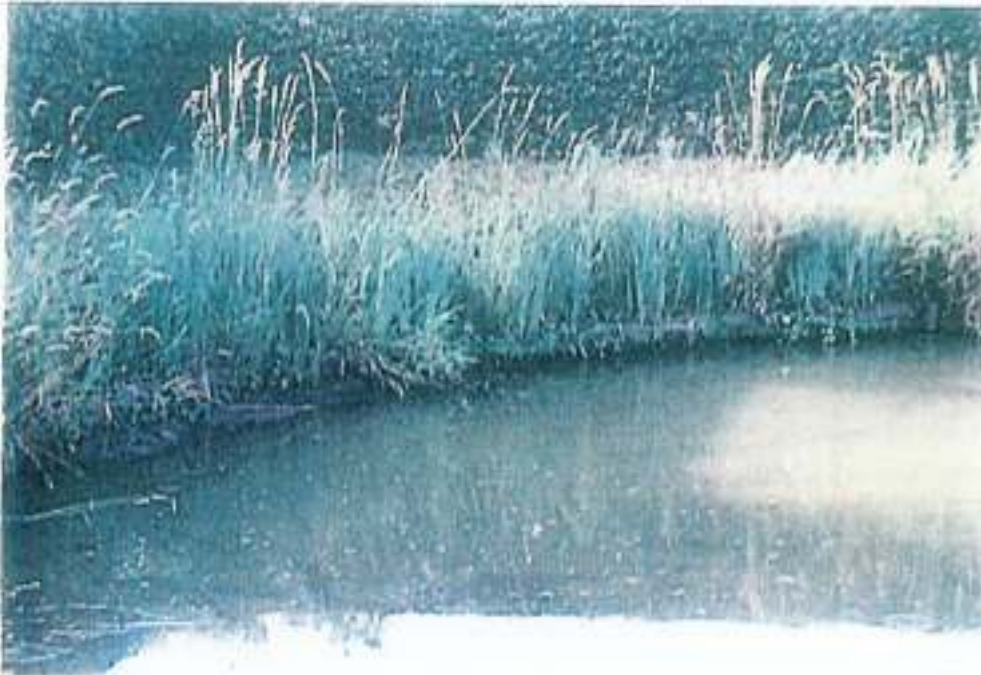
These pre-vegetated coir fibre modules have been widely tested and have proven to be very successful in improving water quality, increasing biodiversity, stabilising banks and reducing sediment transport (*Plate 10*). This action along with the tree management plan will allow a lot more sunlight into the margins and increase productivity on the lake.

Plate 10 - Coir-fibre rolls six months after installation.
