# THE HEATH - PETERSFIELD

GEOLOGY, HYDROLOGY, SOILS AND EDAPHIC RELATIONS WITH SPECIAL REFERENCE TO HEATHLAND RESTORATION

**APRIL 1993**

### RON ALLEN ASSOCIATES

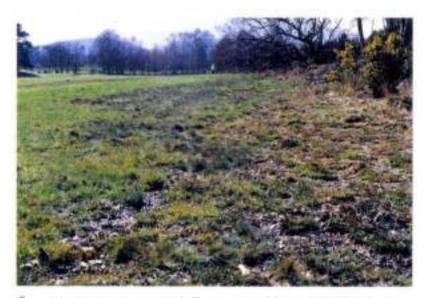
3. Wet Heathland on spring in Compartment 11 near golf club car park.

This area has a high groundwater table and after rain in early April was lying very wet. The soils here have peaty topsoils and sandy subsoils and are formed at a spring site and part of the area may be a silted pond. Vegetation here includes Heather, Moor-grass and Heath Rush, the latter two indicating permanently wet conditions.

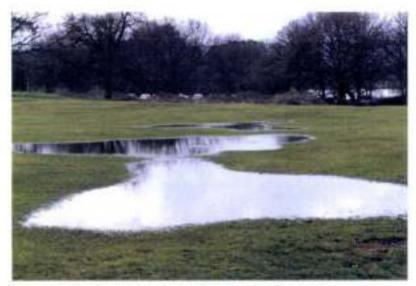
4. Surface pools on thin Terrace Deposits over Gault Clay.

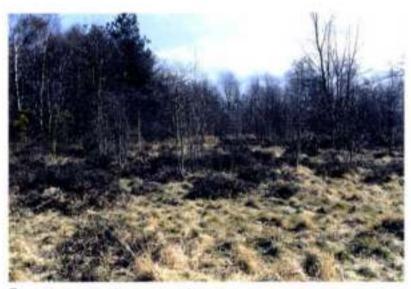
7. Heathland in Compartment 9b.

This hummocky area of tussocky heathland (Photograph 7) has both well drained Shirrell Heath soils and seasonally waterlogged Holidays Hill soils so explaining the mixture of dry and humid heathland plant communities located here. Topsoil pH values of 3.7 indicated extremely acidic conditions and the lowest found on Petersfield Heath. It is likely that this low pH relates particularly to the presence of heathland vegetation which has very acidic litter. Phosphorus and Potassium levels were moderately low but interestingly Magnesium levels were moderately high but this is not unusual in heathland soils.

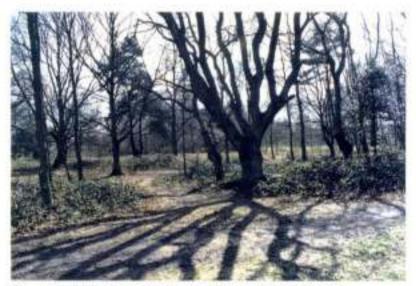
8. Oak Woodland on seasonally waterlogged Hedge End soils.

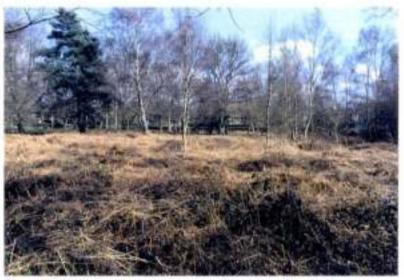
9. Bracken on sandy soils over Upper Pulborough Sandrock.

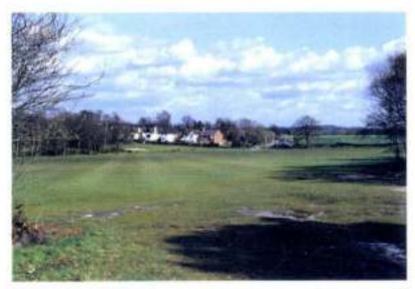
13. Seasonally waterlogged valley side and footslope soils from Music Hill.

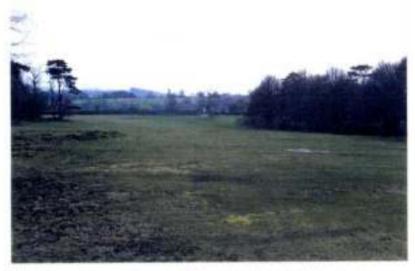
14. Seasonally waterlogged soils in south of Petersfield Heath.

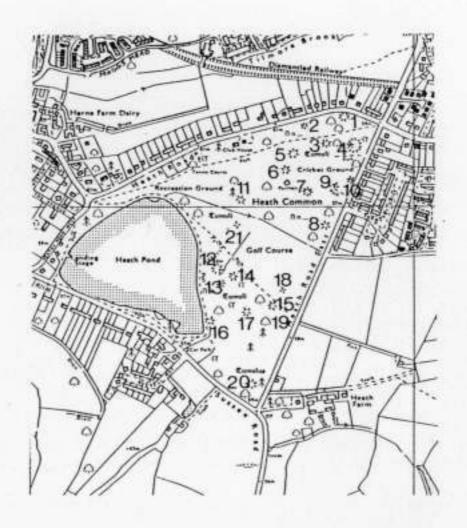
GROUP OF ROUND BARROWS ON HEATH COMMON, PETERSFIELD

NO ON MAP	BARROW TYPE AND DESCRIPTION
1	Bell barrow; slightly damaged.
2	Bowl barrow.
3	Bowl barrow; slightly damaged.
4	Disc barrow; slightly damaged.
5	Bowl barrow.
6	Bowl barrow.
7	Bowl barrow. Bronze Age worked flint has been recovered from this barrow.
8	Bowl barrow.
9	Bowl barrow.
10	Bowl Barrow; slightly damaged.
11	Bowl barrow.
12	Bowl barrow.
13	Saucer barrow.
14	Bowl barrow.
15	Saucer barrow; slightly damaged.
16	Bowl barrow.
17	Bowl barrow; slightly damaged. Bronze Age flints have been recovered from this barrow.
18	Saucer barrow; severely damaged.
19	Bowl barrow.
20	Bowl barrow.
21	Saucer barrow; severely damaged.
