# Petersfield Festival Hall

Elevation Analysis Working Document

May 2021

Foster  
Wilson  
Size

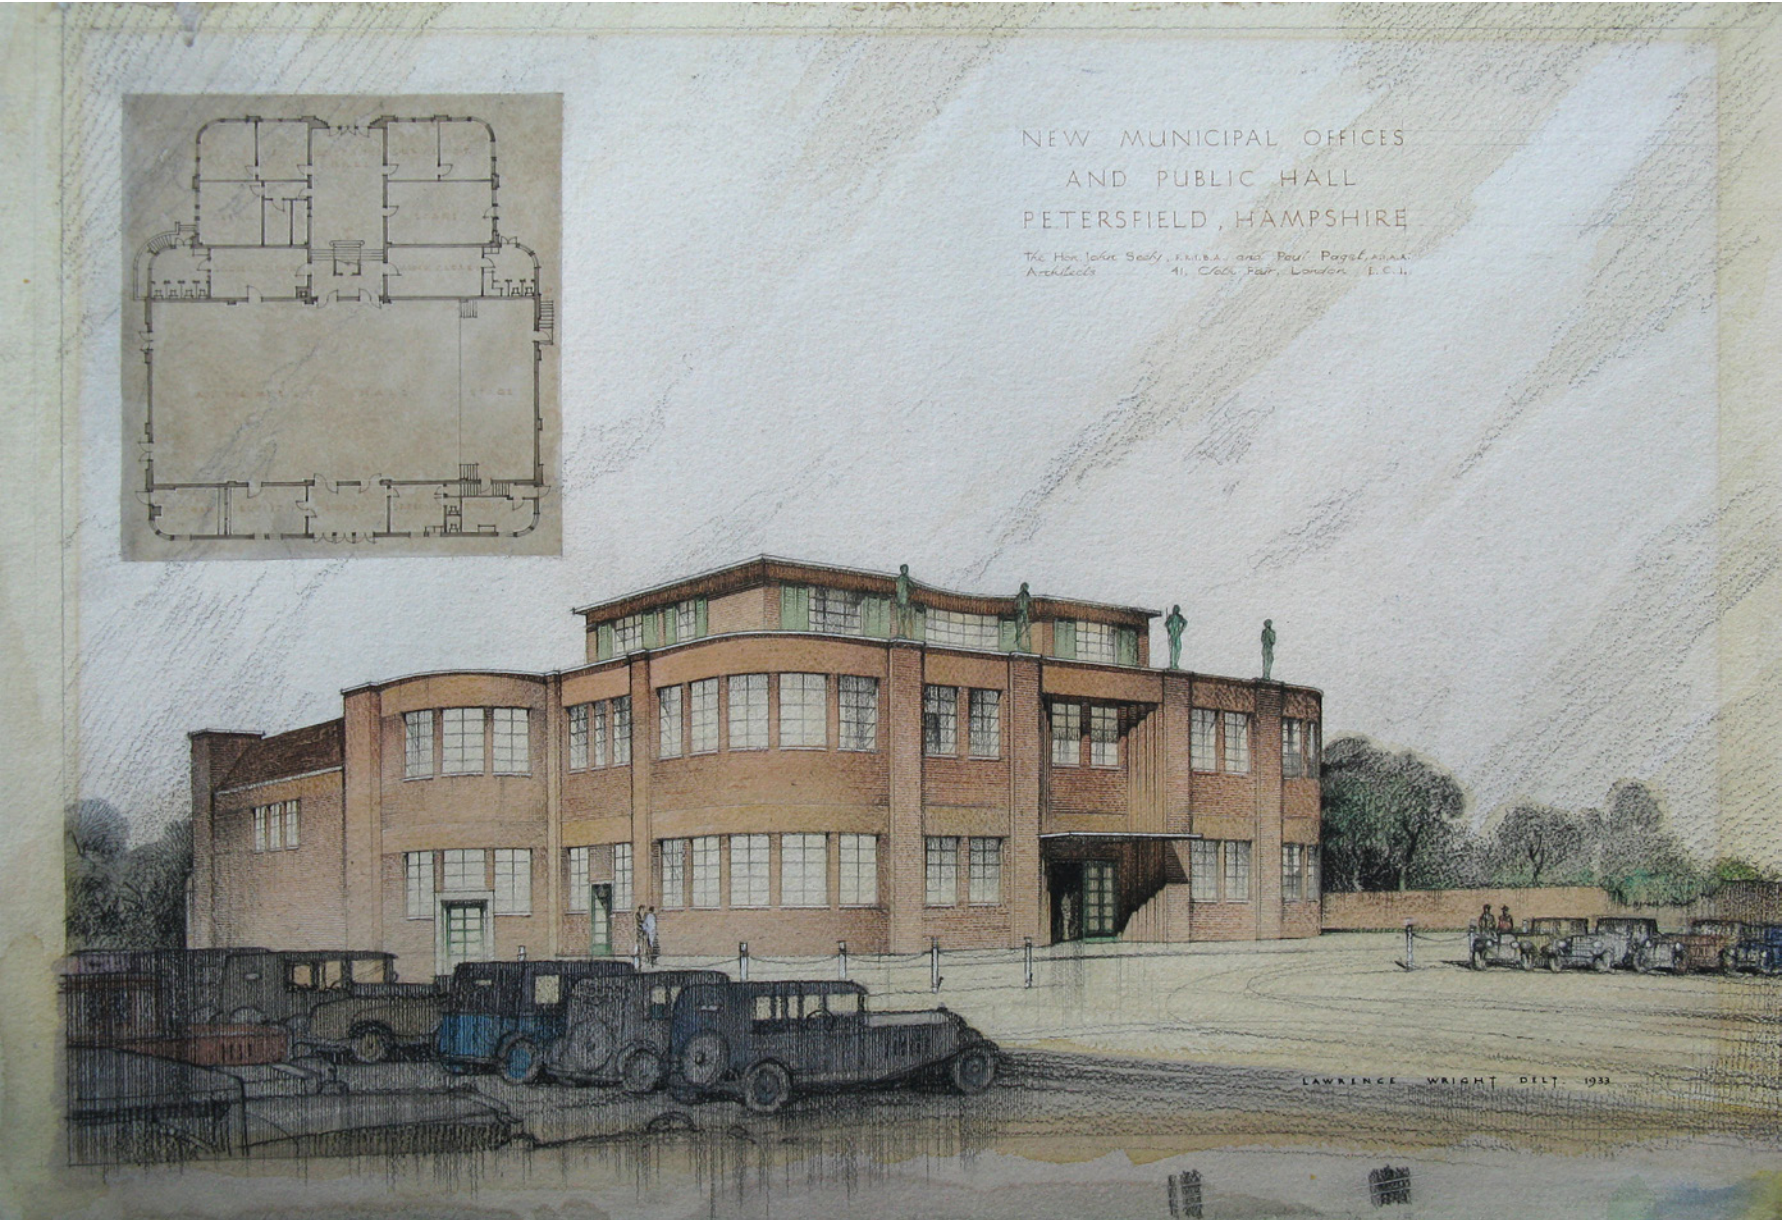
Perspective drawing of the Festival Hall by Lawrence Wright Delt, 1933, exhibited at No.1 The Square before Christmas, 1934.

The initial vision of architect's Seely & Paget was exhibited at No.1 The Square before Christmas 1934 by artist Lawrence Wright Delt. It showed the intended scale and massing of their scheme.

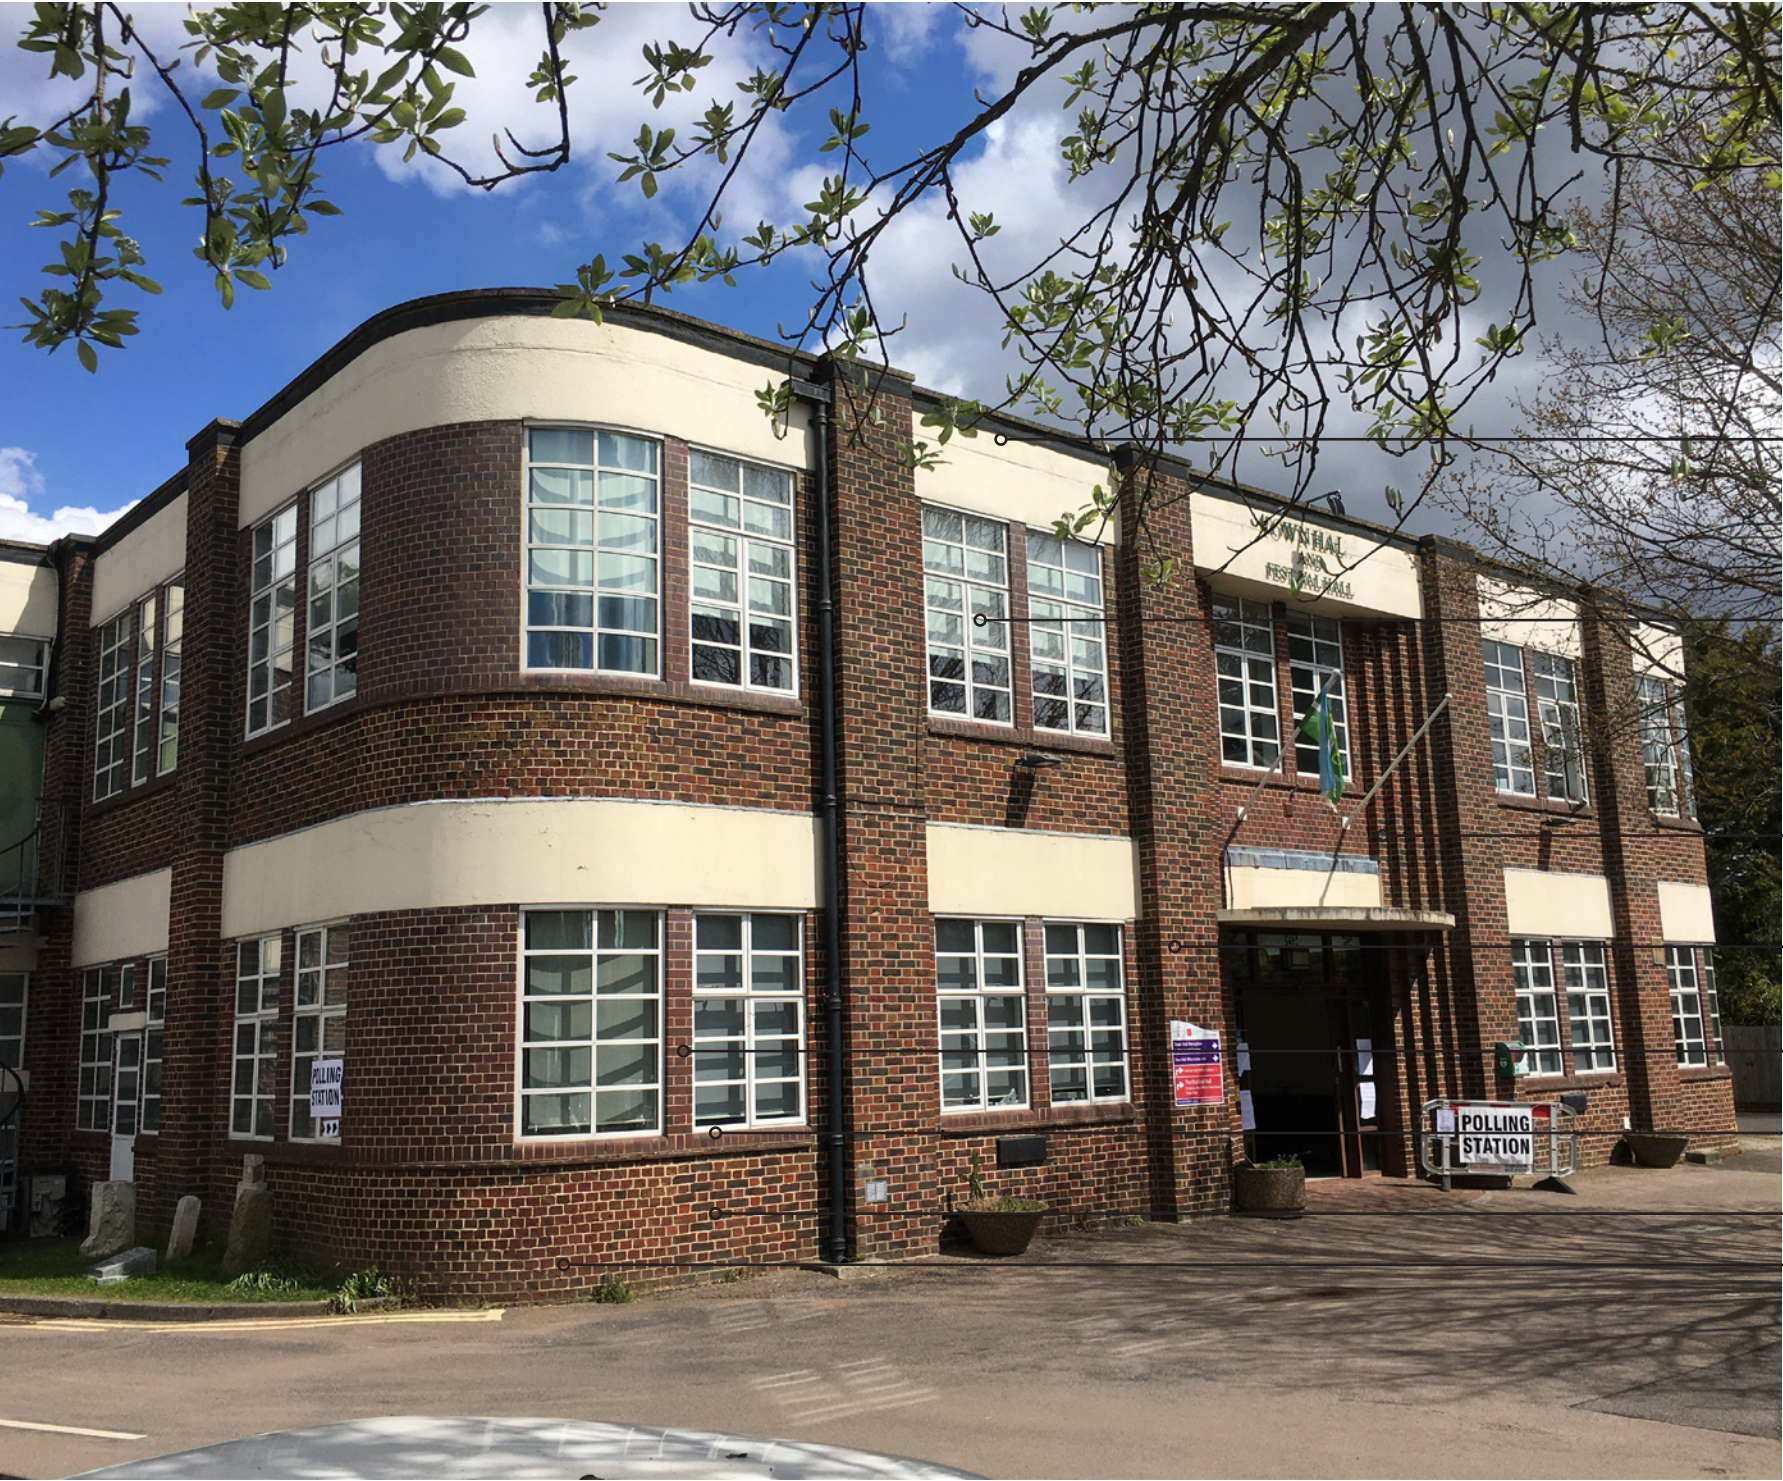
South Wing- 1930's

Banding: the language of this is seen as a strength and a clear feature which should be expressed

Windows not original  
Note: the W20 style may be difficult to achieve with triple glazed, high performance windows.

Attractive staggered brickwork

Columns are structural and expressed on this facade

Brick mullion separating windows

Brick soldier course bullnose sills

Flemish bond brickwork

Snapped header bond on corners

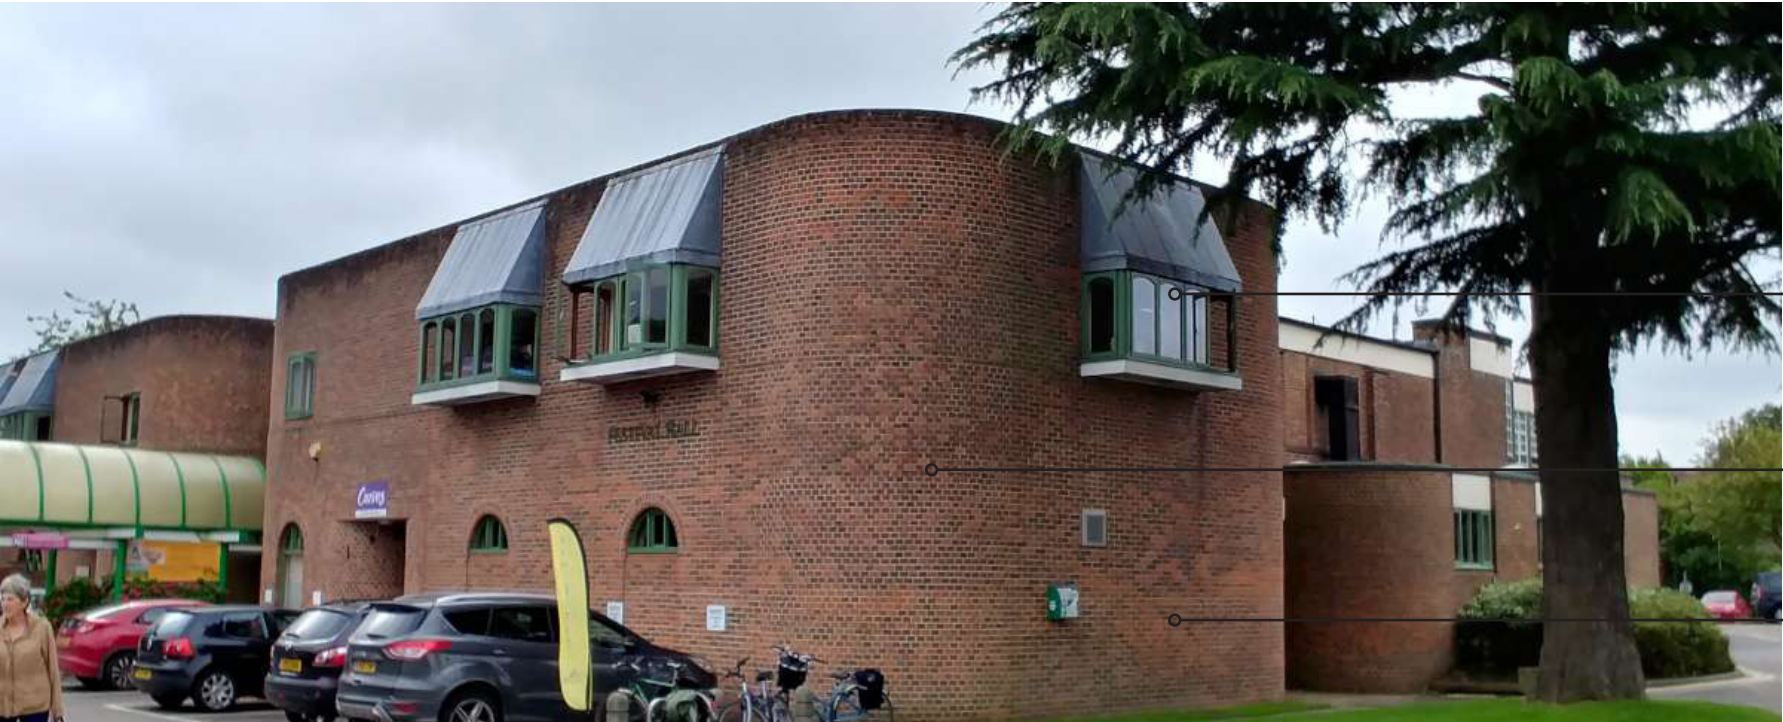
North Wing- 1980's

Overhanging windows are not original and incoherent with the original scheme

Curved corners are only matching features

Brick bonding not the same as the 1930's. On the flat walls it is stretcher bond whereas on the South (original) it is Flemish bond.

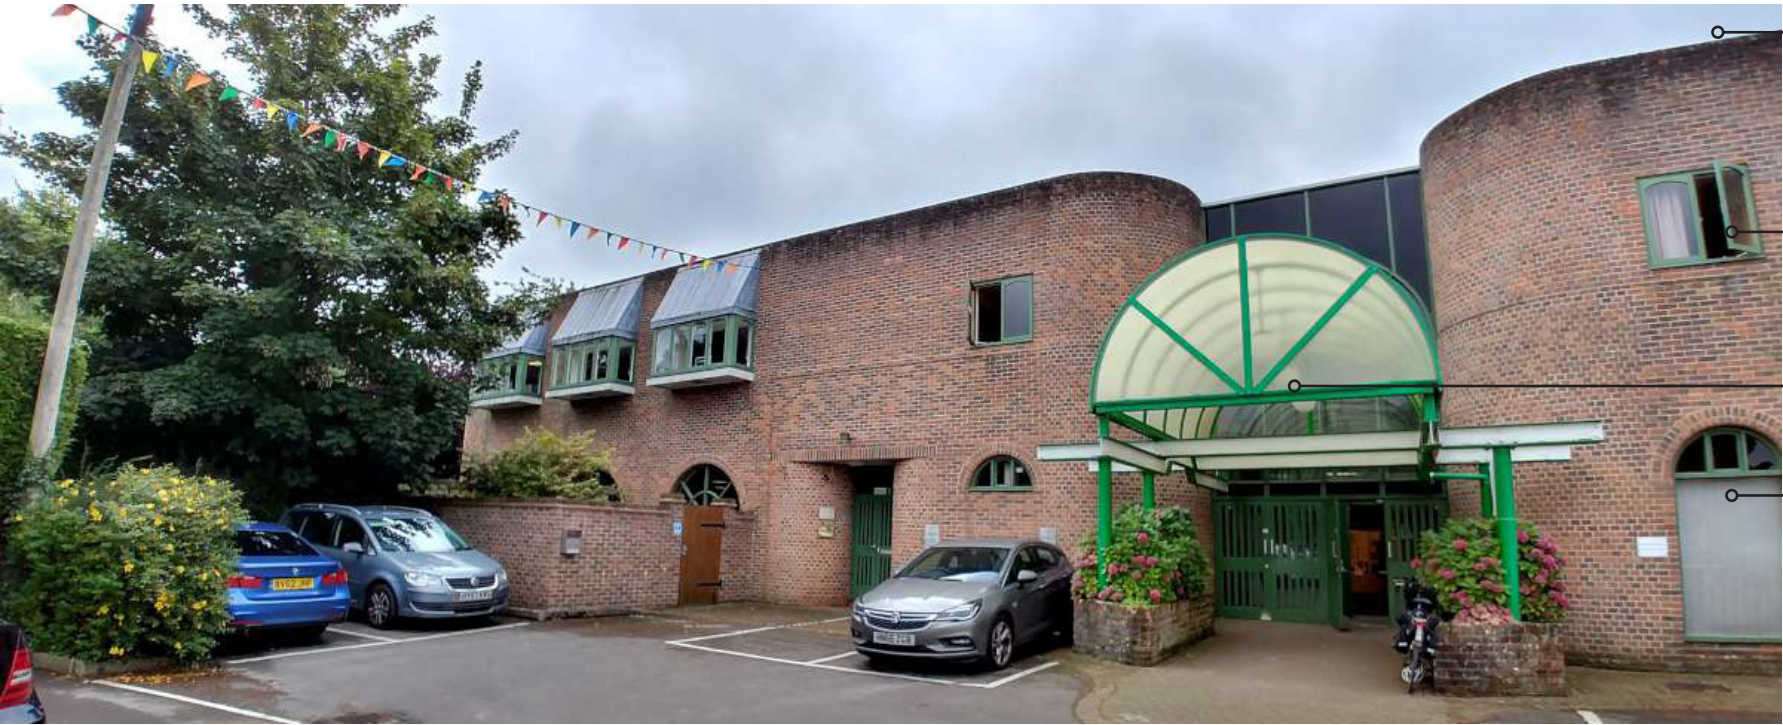
General: language of the South facade is not represented here at all.

Small windows are not ideal. They are also timber framed on the North (1980's facade) which is inconsistent with the South (original)

Canopy and glazing not in good condition and not original

Arched windows are not original and aren't a reflection of the more square/rectangular windows on the original South facade

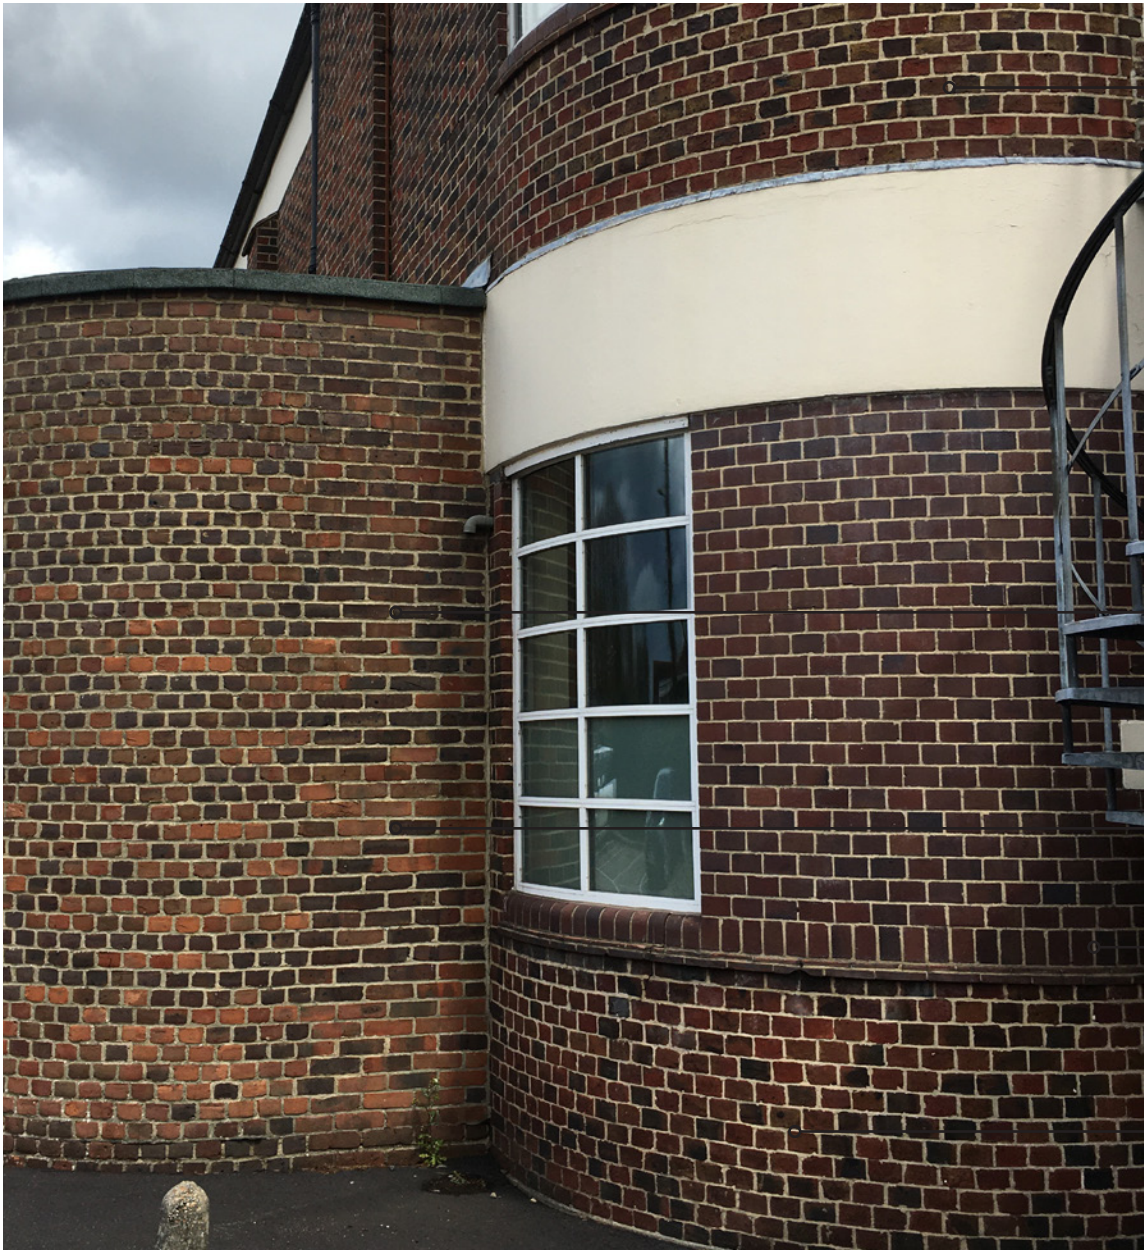
Header bond  
on original  
1930's building

Stretcher bond  
on 1970s/80s  
extension

Header bond

Soldier course  
and bullnose  
detail used for  
visual emphasis  
of sill

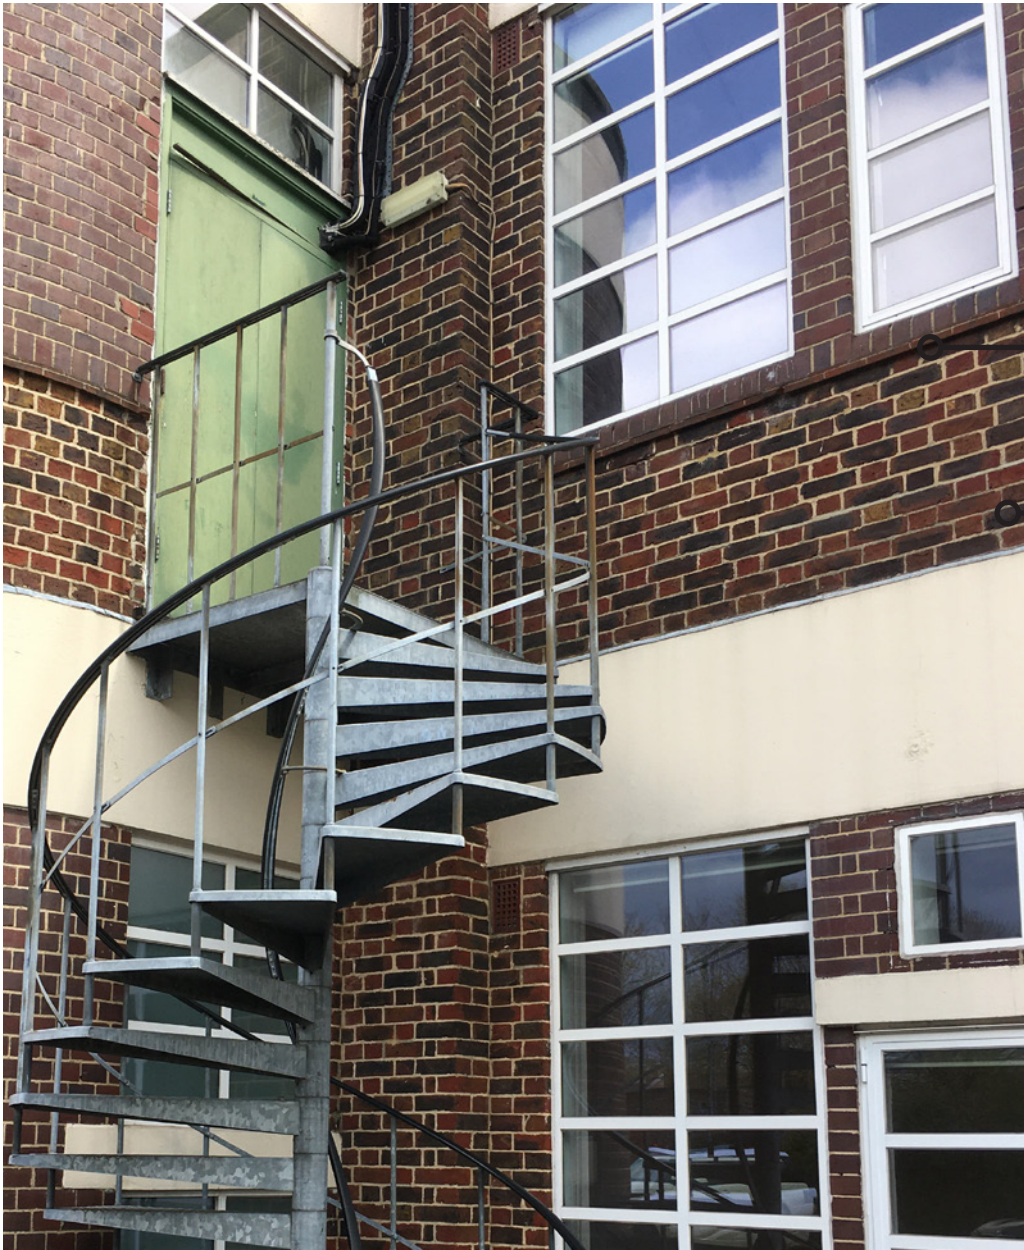
Soldier course  
and bullnose  
detail used for  
visual emphasis  
of sill

Flemish Bond  
on original  
1930's building
